Tecumseh CDI Replacement (TCDI II) Installation Instructions

Overnight Solutions TCDI II - Replaces OEM 610748, 610855 and 610906

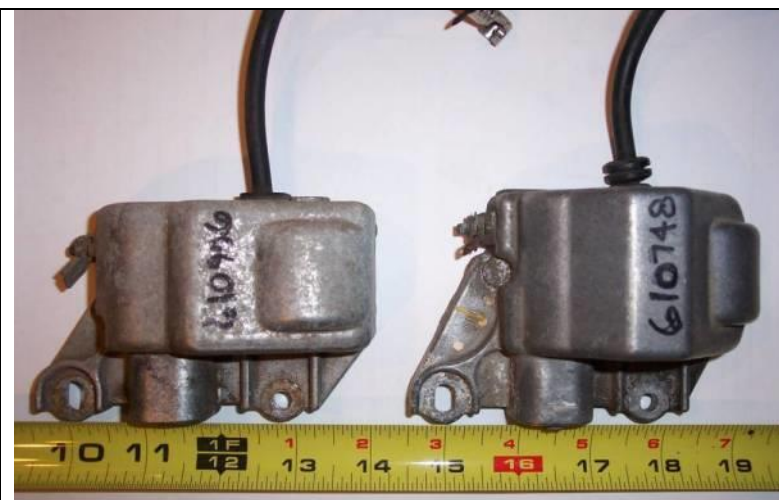
OEM Coils 610748 & 610906 (610855, not shown)

Remove the failed OEM coil shown below by removing the two phillips-head fasteners

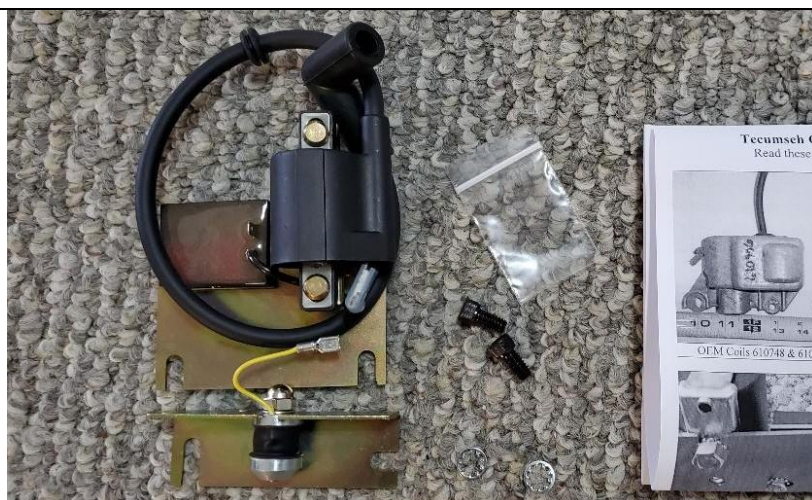
TCDI II, Socket head fasteners & Installation Instructions

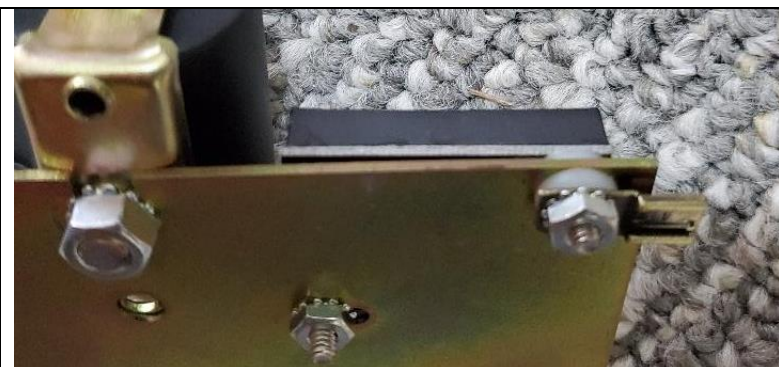
Place QC Terminal from old coil to back of TCDI II

Remove the quick-connect terminal from the old 610748 or 610906; install on reverse side of assembly as shown above

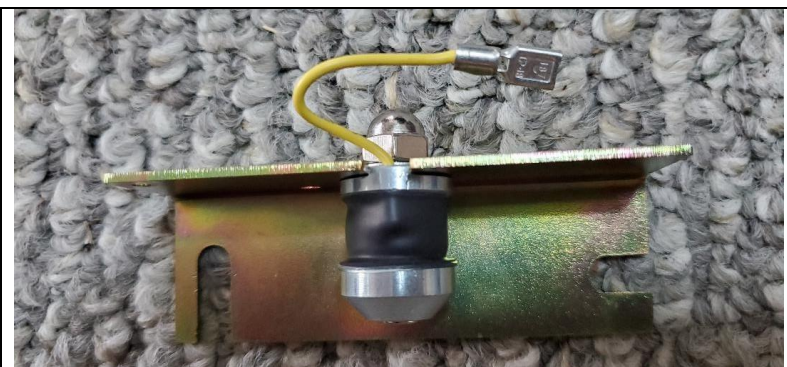
OSMP254 Magnetic Pick-up Coil

Insert the magnetic pick-up from left to right - the magnet should now be resting on the long flywheel pin

Lift the left edge of the pick-up bracket, and then slip a 0.010" feeler gauge between the flywheel pin and the magnet

** Adjust magnetic pick-up by loosening cap-nut - slide in or out as required - take care not to pinch lead wire

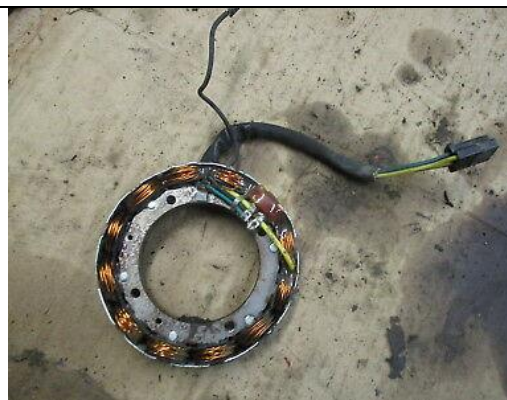
610747 10A Stator
NLA BUT I rebuild them
(Should measure 470Ω
nominal resistance)

Three sources of ignition power are shown below, along with a means of testing. Call with any questions

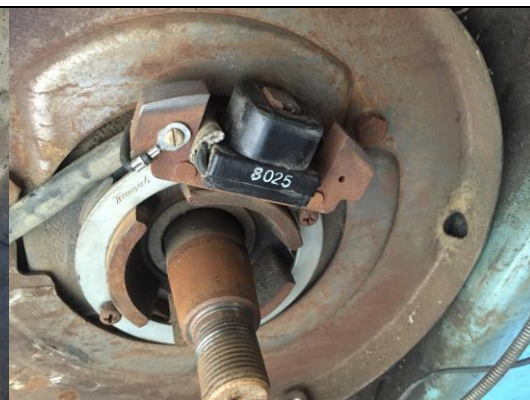
610965 Charge Coil
NLA BUT I rebuild them
(Inductance test only)

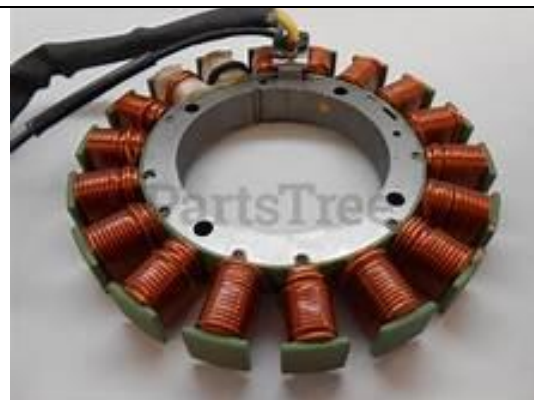
610902 20A Stator
NLA BUT I offer a solution
(Should measure 130Ω or
160Ω nominal resistance)
